Alfen NG9xx series Firmware Release notes

Release notes version 4.14.0
Document version 1.5

April 6, 2021

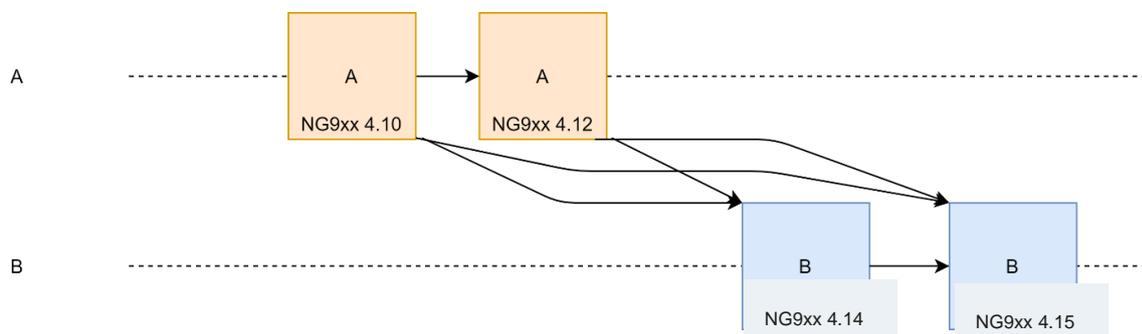
The following diagram shows that firmware version 4.10 can update to 4.12, which still contains encryption key A. When it is updated to 4.14 or 4.15, the encryption key will be updated to “B”.

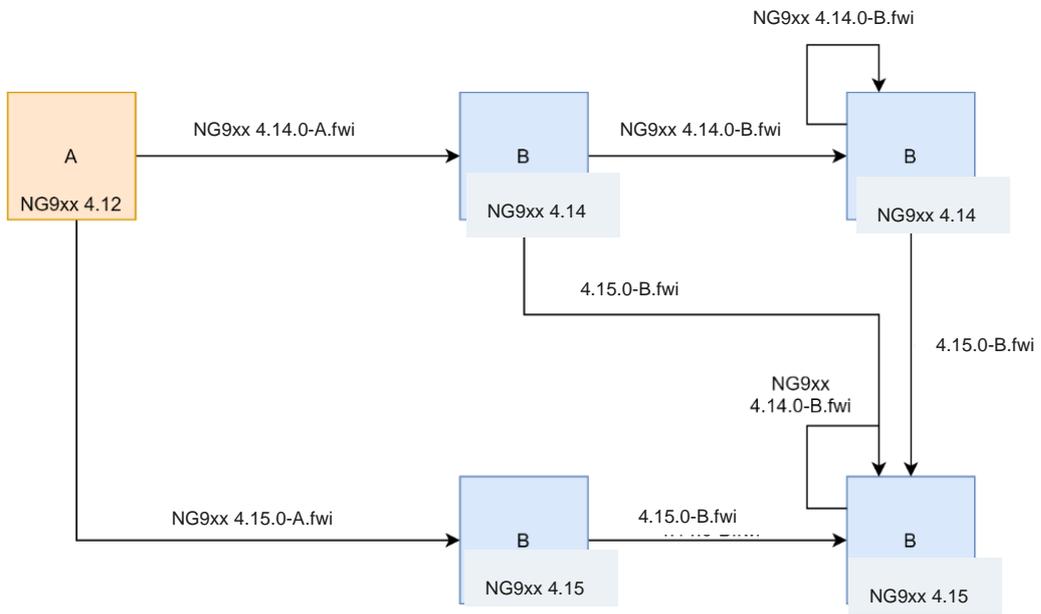
For every release, two fwi files will be published: version A and B. Version A can be used to update a charging station with firmware 4.12 or earlier to the new version. Version B can be used to update a charging station firmware with firmware 4.14 or later to the new version.

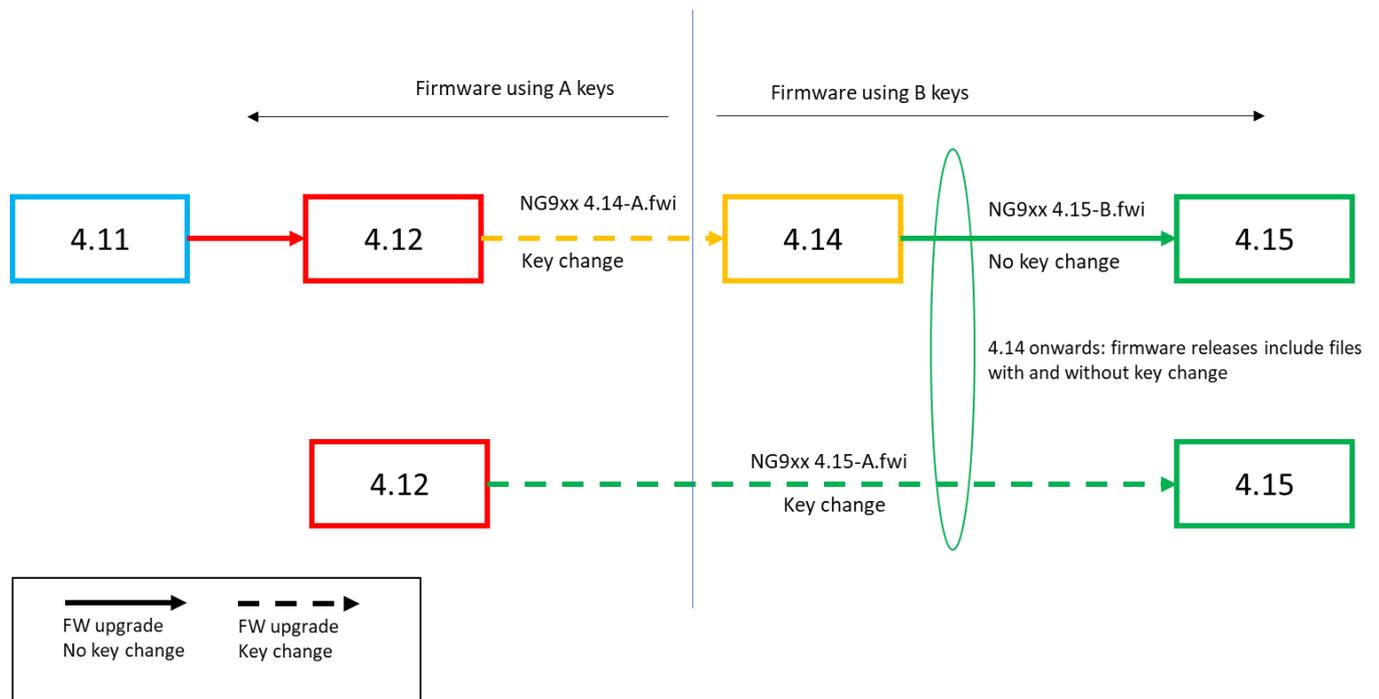
In case the current firmware is 4.12 or older, an upgrade file version A must be selected. If the current firmware is newer than 4.12, version B must be selected.

Below diagram shows an example of upgrade paths with their corresponding fwi file and key changes. Future firmware upgrades will include a release with and without key change.
